## Biological Survey of Swan Pool, Priory Park, Malvern

Will Watson and Giles King-Salter

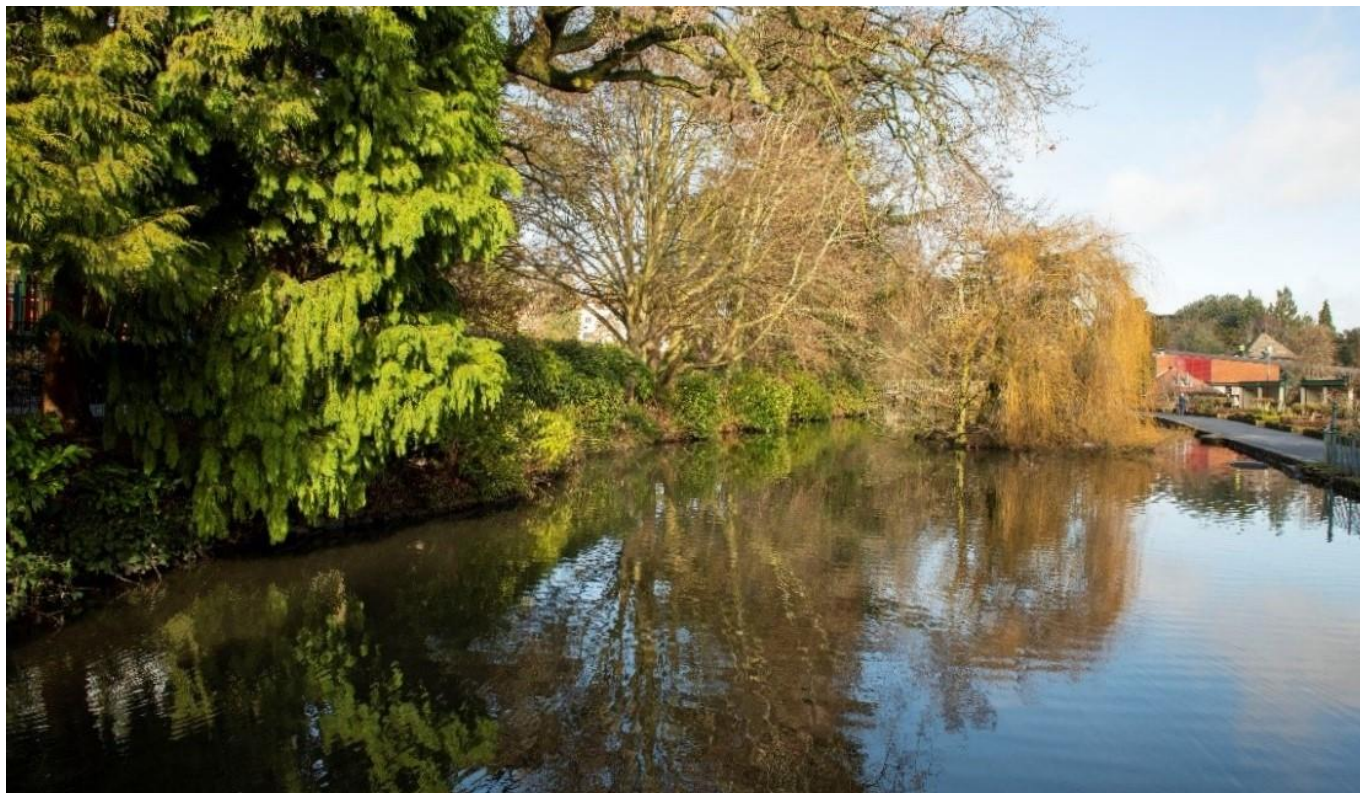
01. Swan Pool (lower pool) looking north towards southern island. Will Watson.

Swan Pool (01) is located in Priory Park, Great Malvern (at SO 7780 4575). It lies 160 metres to the east of Great Malvern Priory on the lower slopes of the Malvern Hills and is thought to have originated as the priory's fish pool. The pool is a prominent feature of the park and actually consists of two pools, with the lower, main pool located at an elevation of 110 m Ordnance Datum (OD) and the much smaller, upper pool located at 111 m OD. The lower pool is linear in shape and follows the natural contour (01). It has two small round islands which were constructed when the site was landscaped as a public park in the 19<sup>th</sup> century, and its base was found to be composed of solid clay. The strip of land to the west, six metres wide, on the upper banks of the pool has been planted with specimen trees including Hop Hornbeam *Ostrya carpinifolia*, Silver Birch *Betula pendula* and Copper Beech *Fagus sylvatica purpurea*, it also includes some naturally regenerating species such as Ash *Fraxinus excelsior*, Goat Willow *Salix caprea* and Holly *Ilex aquifolium*. The land here slopes moderately towards the pool, where there is a low stone revetment composed of Malvern Stone, which has collapsed in several places. The eastern revetment is of concrete and stone construction and is vertical-sided apparently in a good state of repair. The steep stone margins allow little opportunity for native aquatic species of plant to grow.

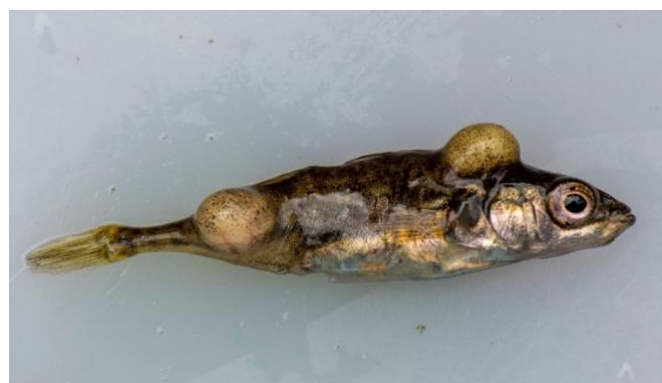
Three-spined Stickleback *Gasterosteus aculeatus* were netted from both the lower pool and the upper pool on three separate occasions during the course of the sampling surveys. Large numbers were present in both pools, and they were the only fish species present in the upper pool. On 16<sup>th</sup> September, over 50% of the sticklebacks in the lower pool were infected with the microsporidian parasite *Glugea anomala* which forms characteristic large white cysts on the body of the fish (05).

05. A stickleback from the lower pool infected with the microsporidian parasite *Glugea anomala*. Will Watson.

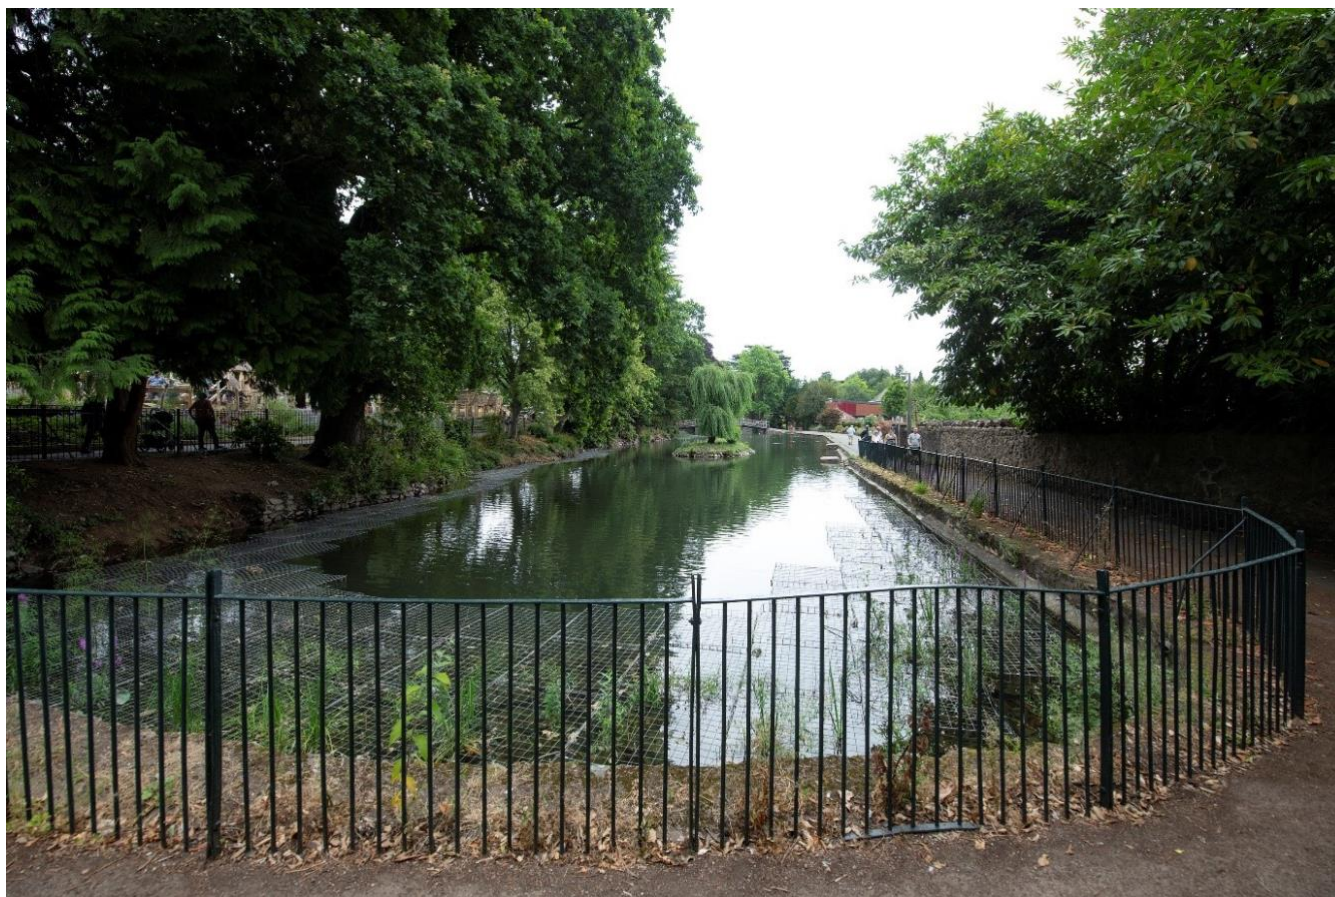
Following the de-silting of Swan Pool in 2022 a range of native aquatic plants have been planted beneath gabion baskets around the pool's margin (10), and native White Water-lily which was present last century has been planted in the middle of the pool. The lower pool will be restocked with a mixture of Roach, Rudd *Scardinius erythrophthalmus* and Perch *Perca fluviatilis* at numbers well below the carrying capacity for a pool of that size, to enable a gradual recovery. The upper pool will be left fish-free in the hope it may be colonised by amphibians. The water during summer 2022 took on a milky appearance. This may be due to a proliferation of bacteria following desilting which in turn maybe a consequence of the disturbance of bottom sediments during the desilting. However, over the last few months the water has cleared (Yasmina Ashcroft *pers.comm.*) and it is expected that the water quality will continue to improve.

10. The lower pool in July 2022 with gabions protecting aquatic plants and the water milky in colour. Will Watson.
